Sub.: Submission of Six-monthly compliance report to the conditions stipulated in the grant order of Environmental Clearance (EC) pertaining to Ostapal Chromite Mines of M/s FACOR LTD.

Name of the Project : OSTAPALCHROMITEMINES, M/S.FACORLTD.

Period of Compliance Report : April'2021 to September, 2021

M/s Vedanta (FACOR Mines) Ltd entrusted the work for carrying of Slope Stability Studies of Pit Slope and Dump Slope of Ostapal Chromite Mine located in Odisha to CSIR-Central Institute of Mining and Fuel Research (CSIR-CIMFR), Dhanbad. Objective of study was to carry out the slope design of pit for ultimate planned pit depth, and dump design for ensuring safety of pit and dump. A combined analysis of pit and dump as composite slope was also to be done as the external OB dump was close to pit. Pit slope dewatering or depressurization scheme along with other recommendations were to be suggested for ensuring safety of men and machineries with reference to slope stability of pit and dump.

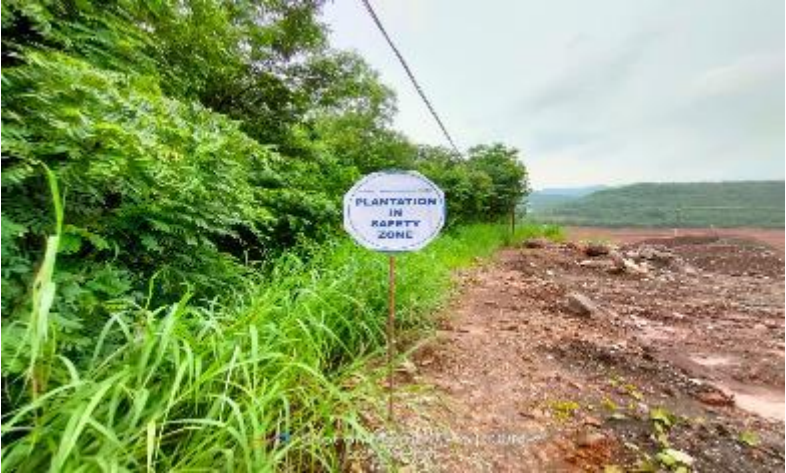
<p style="text-align: center;"><b>Plantation In Safety Zone</b></p>

2.	Necessary forestry clearance under the Forest (Conservation) Act, 1980 for an area of 4.07 hectares forest land shall be obtained before starting mining operation in that area. Till such time mining activities shall be restricted to an area of 64.354 ha for which in principle forestry clearance has been obtained from the Ministry on 03.10.2005	<p>This area is left as Safety Zone area for greenbelt around periphery of forest land of M.L. area and mining operations in this area will not be done.</p>

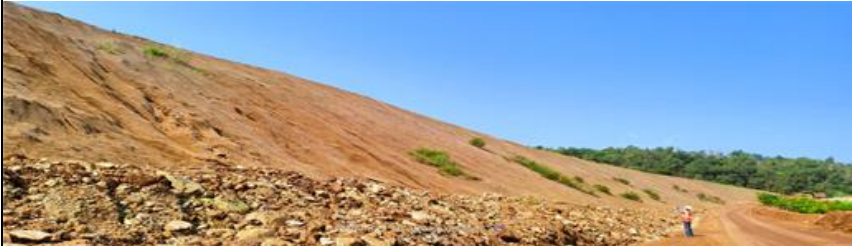
4.	<p>Over burden shall be stacked at earmarked dump site(s) only and should not be kept active for long period. The total height of the dump(s) should not exceed 45m in three stages of 15 m each, keeping overall slope of the dumps below 28°. The proponent shall carry out slope stability study and submit report to the Ministry.</p> <p>The OB dumps should be scientifically vegetated with suitable native species to prevent erosion and surface runoff. In critical areas, use of geo textiles shall be taken for stabilization of the dump. Monitoring and management of rehabilitated areas should continue until the vegetation becomes self - sustaining.</p>	<p>The OB is being dumped at earmarked site only &amp; as per the approved Mining Plan. Technical study is also carried out by CIMFR &amp; all the recommendations are implemented. Overall slope is about 27°.</p> <p>The report has been enclosed as Annexure <b>No.-1</b></p> <p>The inactive benches are being vegetated by suitable native species and massive grass plantation to prevent erosion &amp; surface runoff. The management of the rehabilitated areas of the dumps has been continuing until the vegetation becomes self-sustaining. Further, in the weaker zone/part of the dump is being covered with Geo-textile to prevent erosion &amp; to make it stable by planting the native species scientifically as follows:</p>

<p>Compliance status should be submitted to the Ministry of Environment &amp; Forests on six monthly basis.</p>	  <p style="text-align: center;"><b>Plantation in Dump</b></p>
<p>5.</p>	<p>Trace Metals such as Ni,Co,As, and Hg should be analyzed in dust fall and soil samples for at least one year during summer, monsoon and winter seasons. If concentrations of these metals are found below the standards, then with prior approval of MOEF this specific monitoring could be discontinued.</p>	<p>Collection and analysis of dust &amp; soil samples is done, and the test reports are enclosed in <b>Annexure No.2</b>.</p>
<p>6.</p>	<p>Catch drains and siltation ponds of appropriate size should be constructed to arrest silt and sediment flows from soil, OB and mineral dumps. The water so collected should be utilized for watering the mine area, roads, plantation etc. The drains should be regularly de -silted and maintained properly.</p> <p>Garland drain (size, gradient and length) shall be constructed for both mine pit &amp; waste dump and sump capacity should be designed keeping 50% safety margin over and above peak sudden rainfall (based on 50 years data) and maximum discharge in the area adjoining the mine site. Sump capacity should also provide adequate retention period to allow proper settling of silt material.</p> <p>Storm water return system should be provided.</p> <p>Storm water should not be allowed to go to the effluent treatment plant during high rainfall / super cyclone period. A separate storm water sump for this purpose should be created.</p>	<p>Catch drains around OB dumps and mineral stockyard have already been constructed with siltation ponds at regular intervals to arrest silt and sediments. Whenever required the silts and sediments are being cleaned from catch drains and siltation ponds and maintained regularly. Mine pumped out water is sufficient for dust suppression and plantation purposes. Hence catch drain water is dis-charging outside M.L. area through ETP process. Hence there is no need for collection of water from catch drains from mine area, roads, plantation etc.</p> <p>Garland drains of width 2m, depth 1.5m and length 3424 m with gradient have been constructed for maximum discharge of rainfall in the adjoining areas.</p> <p>There is no chance of flow of storm water into the effluent treatment plant during high rain fall/super cyclone period because the plant is at high reduced level (RL). Hence storm water return system is not required.</p>   <p style="text-align: center;"><b>Garland Drain with Check Dam</b></p>

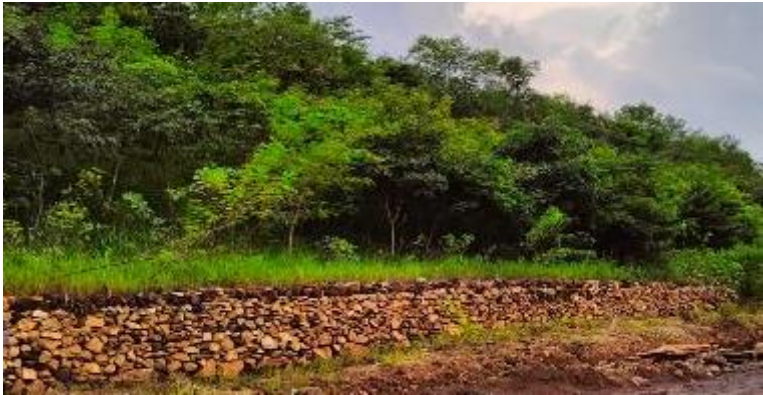
<p style="text-align: center;"><b>Retaining Wall</b></p>

7.	<p>Dimensions of retaining wall at the toe of OB dumps &amp; benches within the mine to check run-off and siltation should be based on the rain fall data.</p>	<p>Retaining wall of width 1.5m and height 1.2m has already been constructed all around the toe of dumps up to a length of 3424 m to check the run-off and siltation.</p>

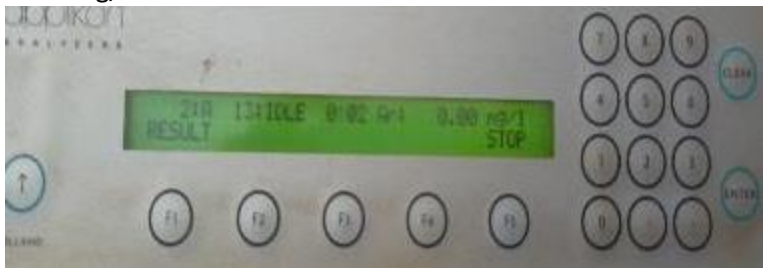
8.	<p>Effluents containing of Cr<sup>+6</sup> shall be treated to meet the prescribed standards before reuse/discharge. Effluent Treatment plant should be provided for treatment of mine water discharge and wastewater generated from the workshop and mineral separation plant. Run off from OB dumps and other surface run off should be analyzed for Cr<sup>+6</sup> and in case its concentration is found higher than the permissible limit the water should be treated before reuse/discharge.</p>	<p>An Effluent Treatment Plant is operating for treatment of Mines discharge water. The conc. of Cr<sup>+6</sup> in treated discharge water is &lt;0.05mg/l.</p>

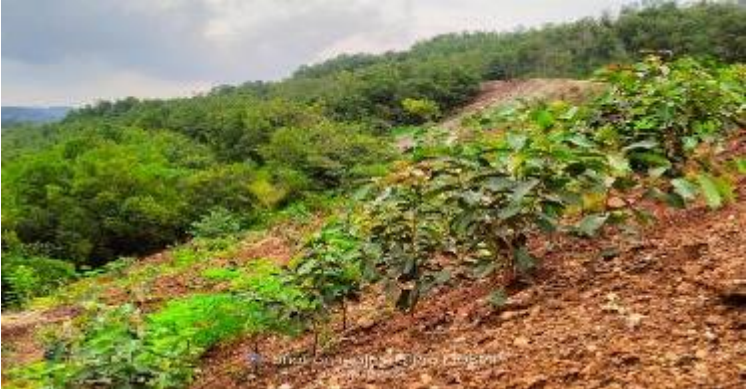
<p style="text-align: center;"><b>Plantation in Benches of the Inactive/dead dump</b></p>

12.	Plantation shall be raised in an area of 33.02 Ha including green belt in an area of 6.56 Ha by planting native species around ML area, OB dumps, and roads around worked out area etc. in consultation with local DFO/Agriculture Department . The density of the trees should be around 2000 plant species per hectare.	<p>Plantation has been done over inactive/dead benches of OB dumps, Roadside, around C.O.B. Plant and other places in an area of 34.92 Ha. Plantation is being carried out in consultation with local Forest Department.</p>

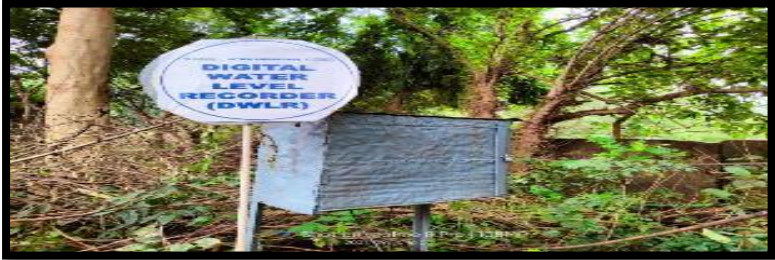
13.	Regular monitoring of ground water level & quality should be carried out by establishing a network of existing wells and constructing new piezometers during the mining operation. The monitoring should be carried out four times in a year– pre-monsoon (April -May), monsoon (August), post - monsoon (November) and winter (January) and the data thus collected may be sent regularly to MOEF, Central Ground Water Authority and Regional Director Central Ground Water Board.	<p>Monitoring of ground water level &amp; quality is being carried out third party accredited agency. Further, DWLR with telemetry system fitted in Piezometer holes to carried out the real time monitoring of Ground water level.</p>

<p>The Monitoring reports has been sent &amp; the monitoring report for the period from April'2021 to September'2021 is enclosed as: Ground water level &amp; Quality : <b>Annexure No.-3 &amp; 4</b></p>

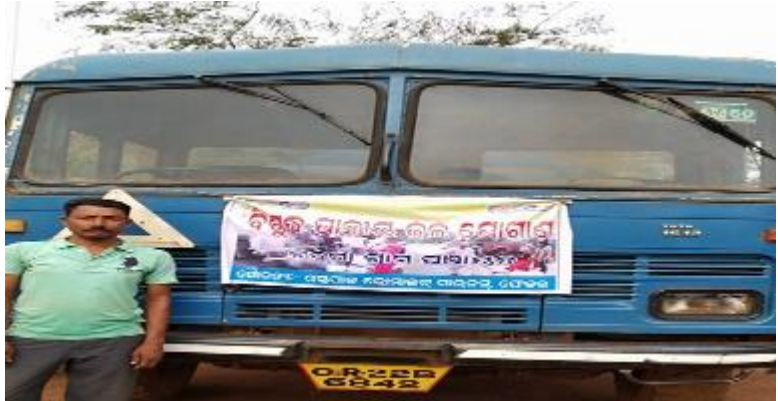
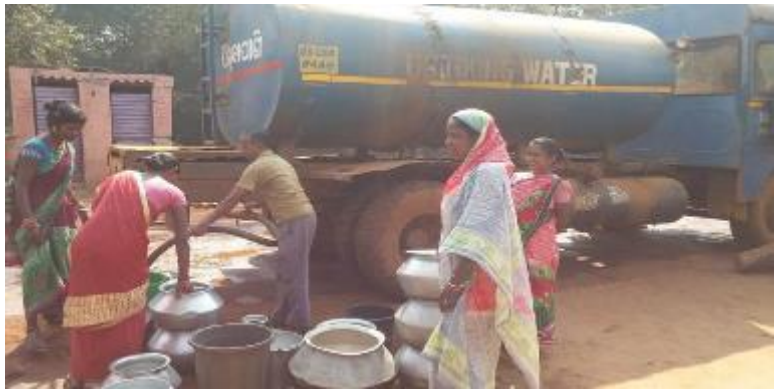
<p style="text-align: center;"><b>Water provided to nearby village by tankers</b></p>

15.	Project Authorities should meet water requirement of the peripheral village(s), especially, if the village wells go dry due to mine de - watering.	<p>As a part of peripheral development nos. of borewell have been constructed in nearby villages and also potable water is being provided to nearby villages by water tankers.</p> <p>Reading of the abstraction structures, used for water supply to local community are enclosed for reference as <b>Annexure No.:6</b></p>

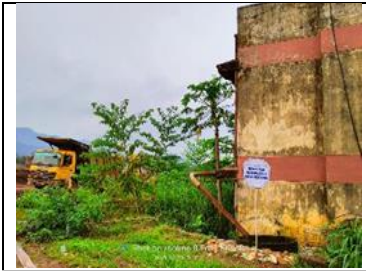
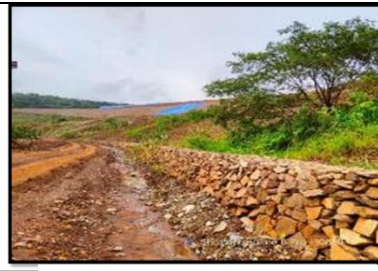
</div> <div style="display: flex; justify-content: space-around; margin-top: 5px;"> <span><b>Rooftop Rain-Water Harvesting</b></span> <span><b>Garland drain</b></span> </div>

17.	Suitable rain water harvesting measures on long-term basis shall be planned and implemented in consultation with Regional Director, CGWB.	<p>Rainwater has been collected in different pits for suitable rain water harvesting measures.</p> <div style="display: flex; justify-content: space-around;">

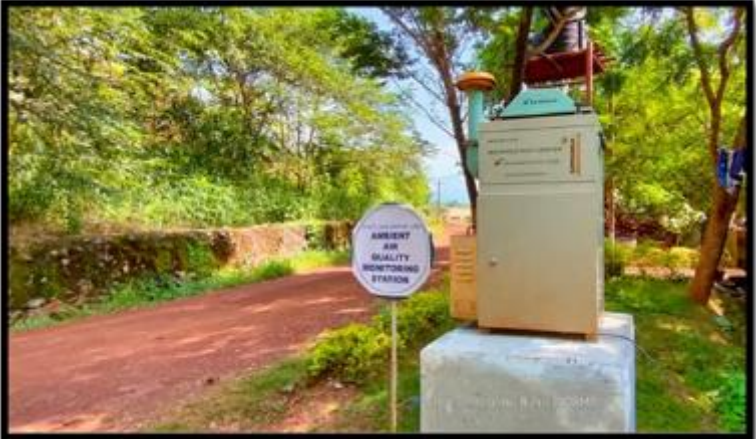
4	Four ambient air quality -monitoring stations should be established in the Core zone as well as in the Buffer zone for RPM, SPM, SO <sub>2</sub> & NO <sub>x</sub> monitoring. Location of the stations should be decided based on the meteorological data, topographical features, and environmentally and ecologically sensitive targets in consultation with the State Pollution Control Board.	<p>Ambient Air quality monitoring stations has already been established in consultation with SPCB.</p>

<p style="text-align: center;"><b>Ambient Air Quality Monitoring System</b></p>
5	Data on ambient Air Quality (RPM, SPM, SO <sub>2</sub> & NO <sub>x</sub> ) should be regularly submitted to the Ministry including its Regional Office at Bhubaneswar and the State Pollution Control Board / Central Pollution Control Board once in six months.	<p>Test reports on Ambient Air Quality monitoring viz., PM<sub>10</sub>, PM<sub>2.5</sub>, SO<sub>x</sub>, NO<sub>x</sub> &amp; CO is being monitored &amp; submitted regularly. Monitoring report for the period April, 2021 to Sept, 2021 is enclosed as follows:</p> <p><b>Annexure No.-9 : Core Zone</b>  <b>Annexure No.-10 : Buffer Zone</b></p>

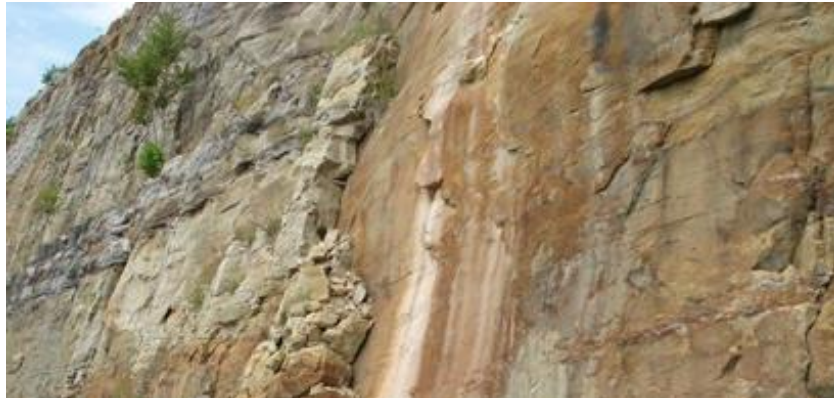
Fig.3: Plane failure

The stability of the slope primarily depends on the slope geometry and strength properties of the slope materials. Ground water and surface water flow conditions also plays a critical role on the stability of dump and pit slopes. The orientation and other properties of discontinuity planes in rock mass with respect to slope face determines the types of failure possible within that slope. Generally, plane, wedge, circular and toppling types of failure occur in rock slopes as shown in figure 3, 4 and 5, while in soil slopes and weathered / highly fractured rock slopes circular failure is the main type of failure. After identifying

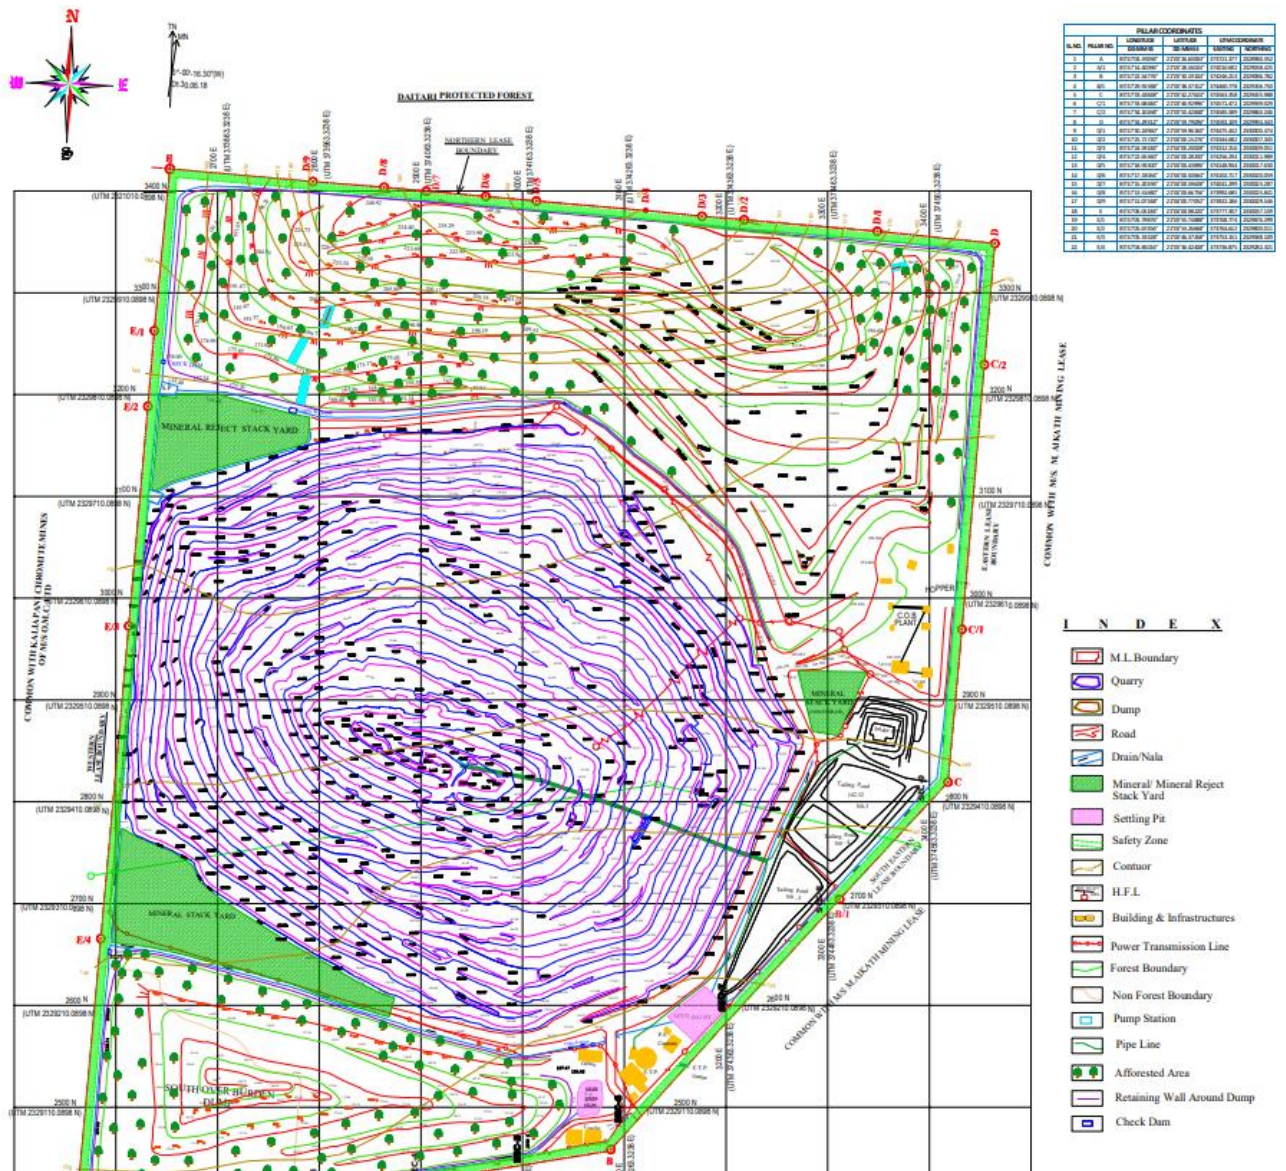
Fig: 6: Surface Plan of pit and dump of Ostapal Pit

The slope stability analyses of planned, and ultimate pit and dump slopes have been done on representative cross sections provided by the mine management using GALENA software. Surface plan of the mine showing pit and dumps and locations of sections is given in Fig. 6 and 7. The existing transverse sections have been shown in fig. 8 to 13 and longitudinal section along LL' is shown in Fig. 14. Locations of these sections have been shown on plan in fig. 7. Transverse sections along Sect-4 and Sect-5 are deeper planned sections hence stability analysis for factor of safety of hangwall and footwall slopes have been done along Section 4 and 5. Stability analysis has also been performed for longitudinal section along LL'. Results of slope stability analysis and design of slopes have been presented in Fig. 15 to 22.

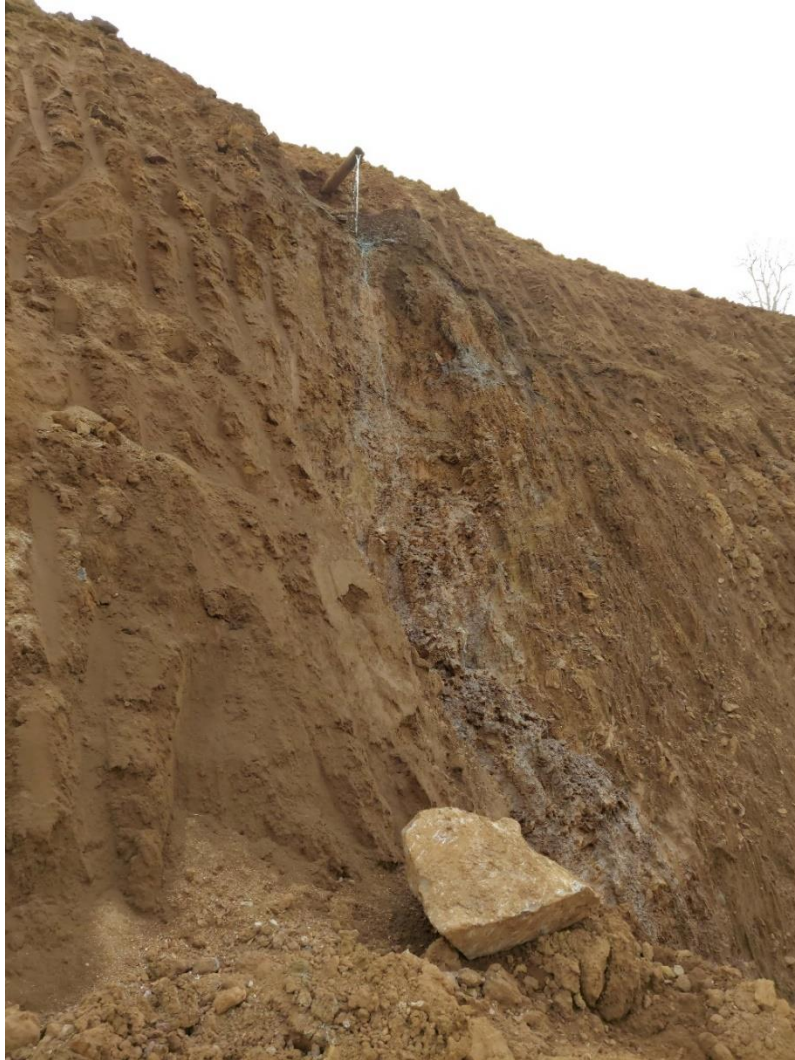
Fig. 39: Water seepage from slope wall

Based on analysis of physical observations of water seepage conditions at Ostapal Chromite Mine, hydrological report of the mine, and additional inputs provided by mine management on seepage locations, CSIR-CIMFR recommends the slope water management plan as for slope depressurization as follows. It is advisable to implement the recommendations at the earliest to improve the condition of slope stability at the mine. Water seepage and wet slope wall problems existing at Ostapal Chromite mine can be seen from through figures 39,40 and 41.

Slope depressurization through horizontal drains will also provide opportunity of further steepening of the slope from existing slope angle. Slope depressurization through a system of horizontal drains as suggested will improve the slope stability significantly.

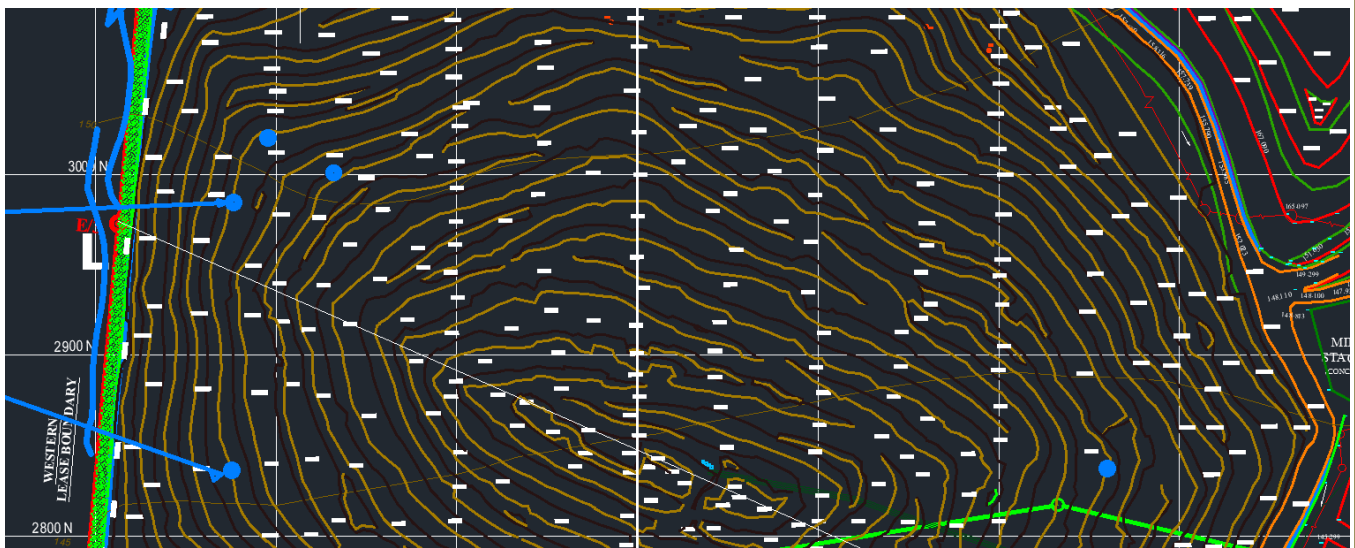
Fig.42: Five Major Seepage Zones of Ostapal Chromite Mine (shown by Blue Circles).

Five water seepage locations (S/1, S/2, S/3, S/4 and S/5) were identified at Ostapal Chromite Mine whose locations (Easting, Northing and RL) have been shown in fig. 42 and Table 6. Horizontal drainage holes are recommended for depressurization of slope walls and for pushing back the phreatic surface away from slope walls of pit. This will improve the stability of slope and the steepening of slope will be feasible due to increase in shear strength of slope walls. Position and orientation of the horizontal holes are shown in Fig. 44, 45 and 46 and Table 7. Schematic sectional view of horizontal drainage holes (4 inch diameter hole with about 3 inch slotted or perforated PVC casing) is shown in Fig. 43. Drainage holes should be kept inclined upward at 5 degree from horizontal.
